February 2001

Lower Granite Dam

Radial Gate Inspection and Testing

US Army Corps of Engineers, Walla Walla District

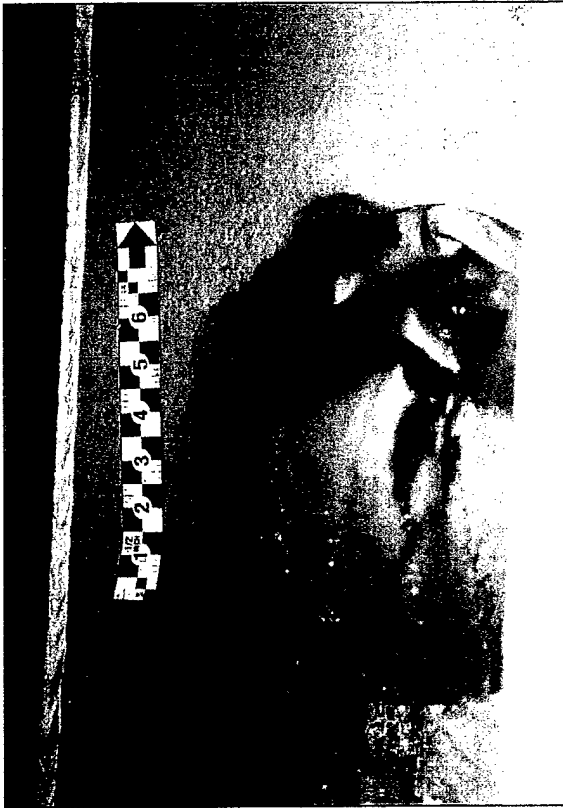
- Prior to the inspection of the upstream face of the gate and waterblasting, an approximately 10-inch diameter paint blister was observed on the downstream side of the skin plate. The blister was located between the middle and top horizontal girders, approximately 7-feet from the left side of the gate (looking downstream) and approximately 6-feet above the transition between the 1/2-inch and 3/8-inch skin plate. The blister did not appear to be leaking water at the time, however, rust stains were observed on and beneath the blister. After waterblasting the upstream surface of the gate, the blister developed several leaks, see Photo. 24 and Photo 25. During the downstream inspection of the gate the blistered paint was removed to expose the hole in the skin plate, see Photo 26. The actual hole through the skin plate was roughly oblong and approximately 1/4-inch wide and 1/8-inch tall.

***Photo. 25: Skin plate leak
prior to removal of
paint.***

- The leak was patched by Gus Hernandez, USACE, on October 17th using META-LOX™ Industrial-Grade Metallic Patching Compound, a 2-part epoxy and resin compound.

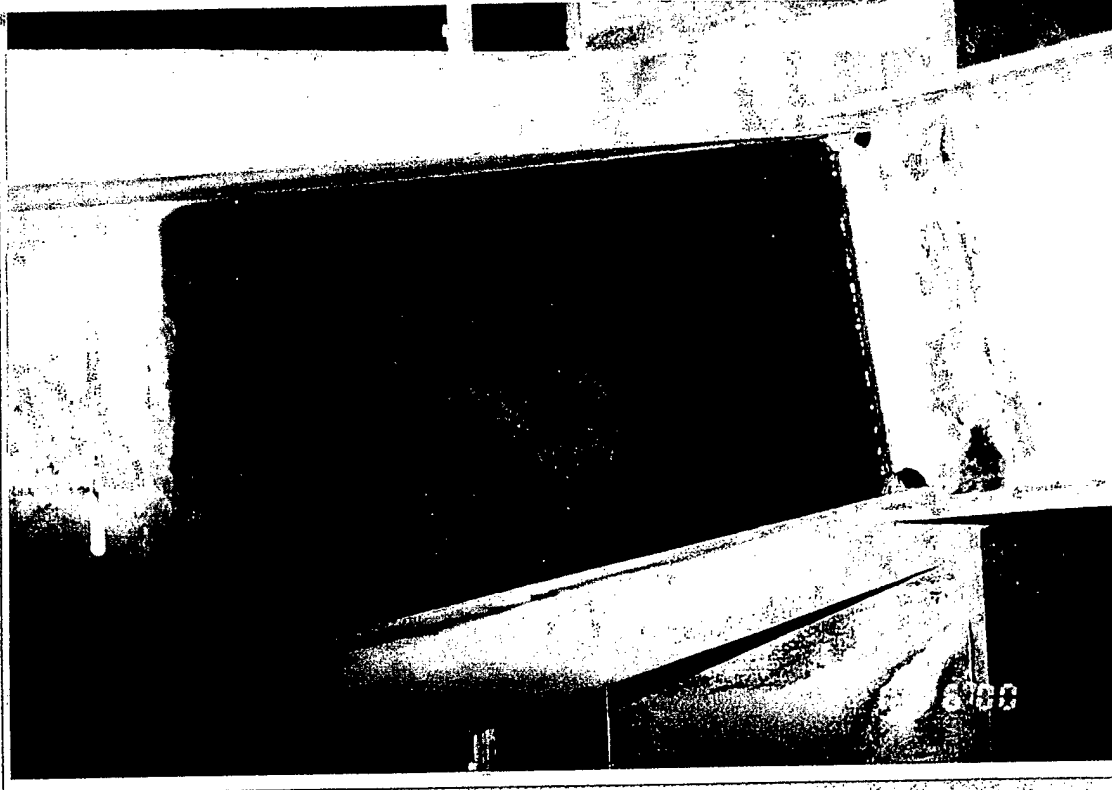
Gate 1

Upstream end, bottom radial strut.
Ponding water between strut flanges
and horizontal girder flange due to
poor drainage.

- Enlarge the drain holes at upstream end of lower radial struts. The recommended size for these drain holes is 1 1/2 - inch in diameter.
- For all new and enlarged drain holes, the holes should be drilled, not flame cut, to reduce jagged edges which snag debris. If drilling holes is not feasible, then the edges of the flame cut holes should be reamed smooth.

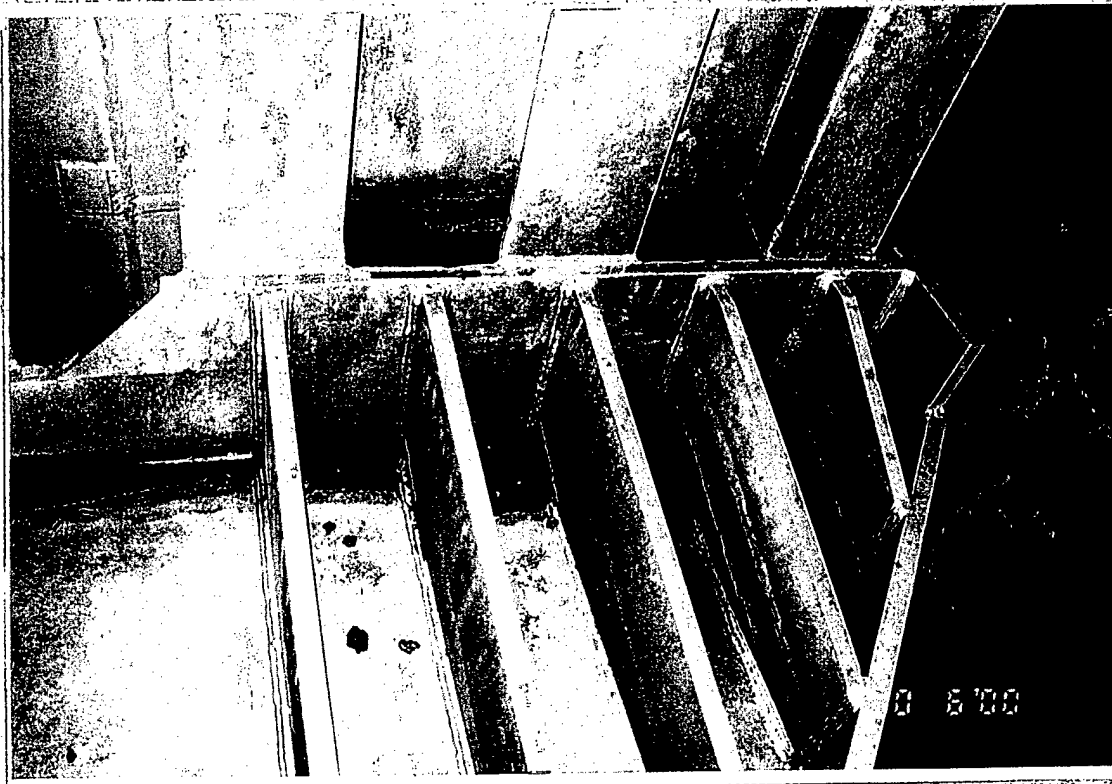
Gate 1

Left end of bottom horizontal girder.
Standing water, no drainage between
multiple stiffeners. Horizontal girder
to skin plate stiffeners, standing
water, debris and no drainage

- Install drain hole between the multiple stiffeners at ends of the bottom horizontal girders. The recommended size for these drain holes is 1-inch in diameter.

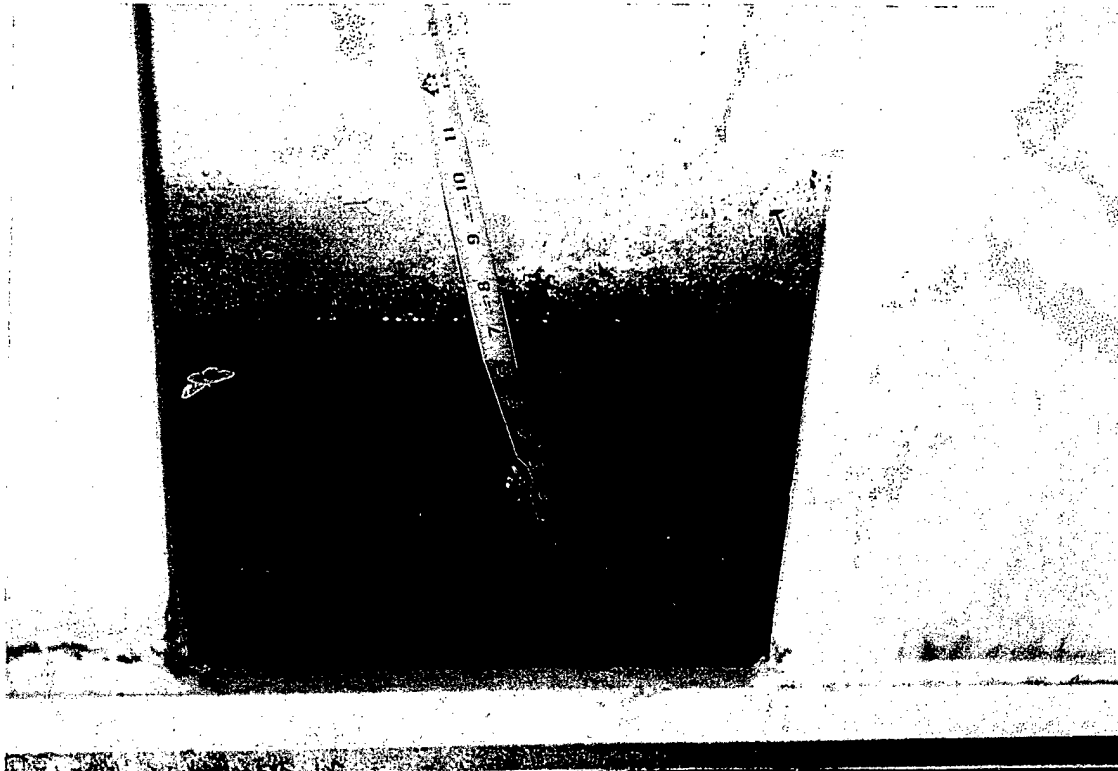
Lower
Granite
Dam
10/06/00
1-7

Gate 1
Bottom seal closure plate looking
upstream. Standing water between
closure plate, purlin webs and
skinplate. Typical.

- Install drain holes in the downstream portion of the bottom seal plate between every purlin. Note: the rubber bottom seal is located between the bottom seal plate and the bottom seal keeper plate. The hole should not be flame cut with the rubber bottom seal in place. The recommended size for these drain holes is 1-inch in diameter.

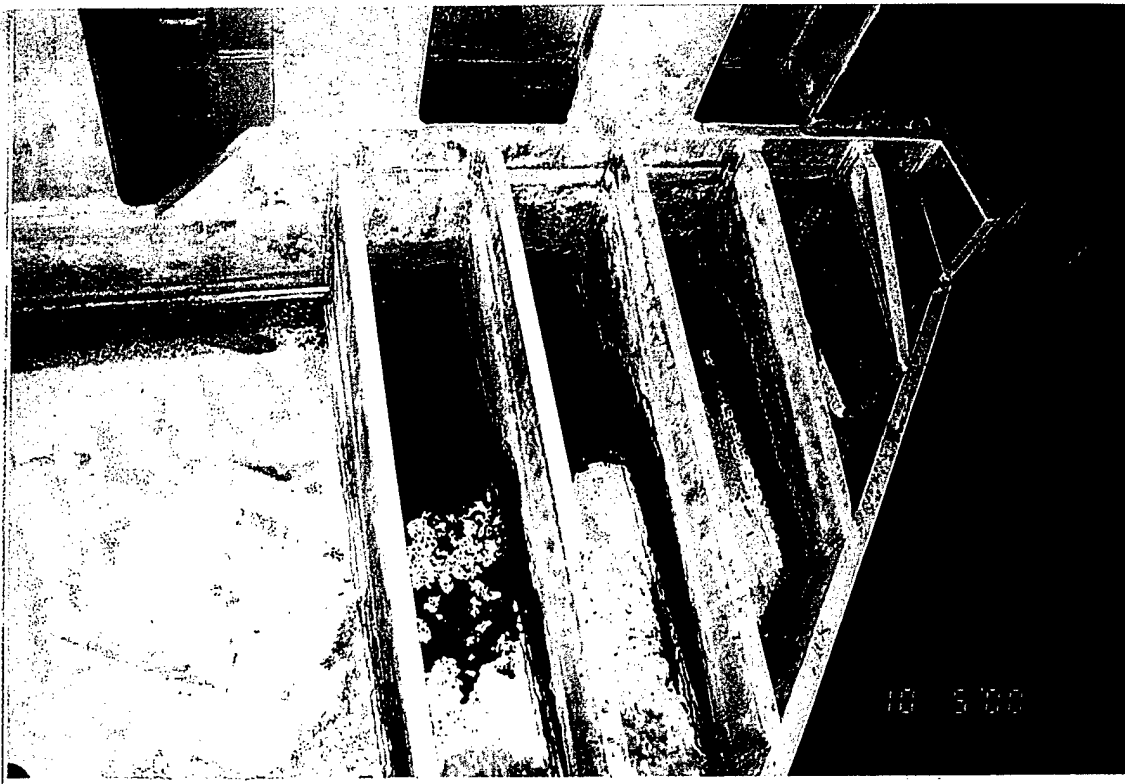
Gate 2

Left end of bottom horizontal girder.
Standing water, no drainage between
multiple stiffeners. Horizontal girder
to skin plate stiffeners, standing
water, debris and no drainage

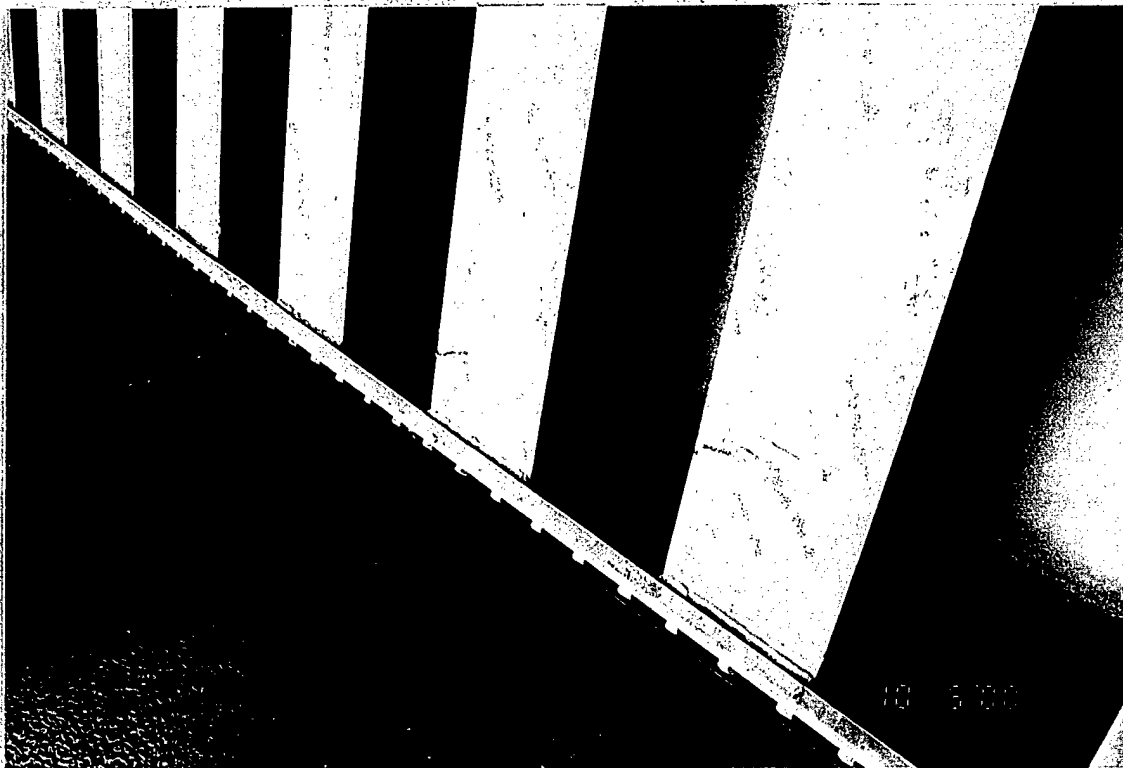
Gate 2

Bottom seal keeper bar and closure
plate, typical.

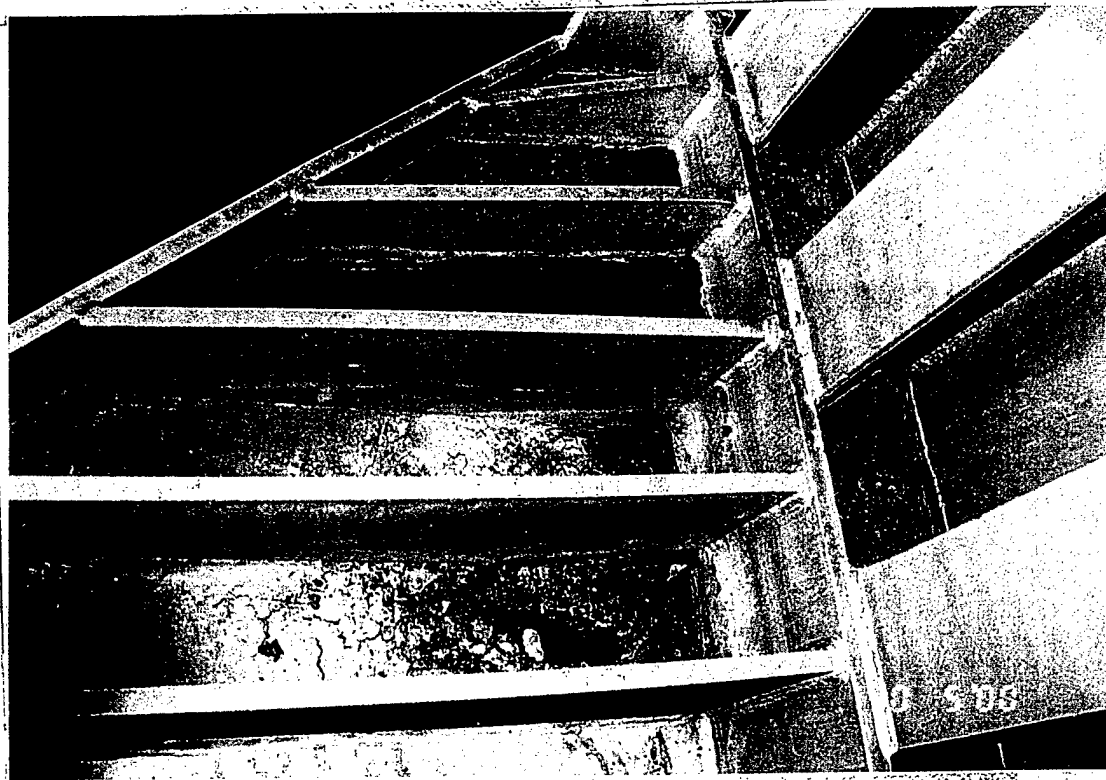
Gate 2

Close-up, right end of bottom
horizontal girder. Standing water, no
drainage between multiple stiffeners.

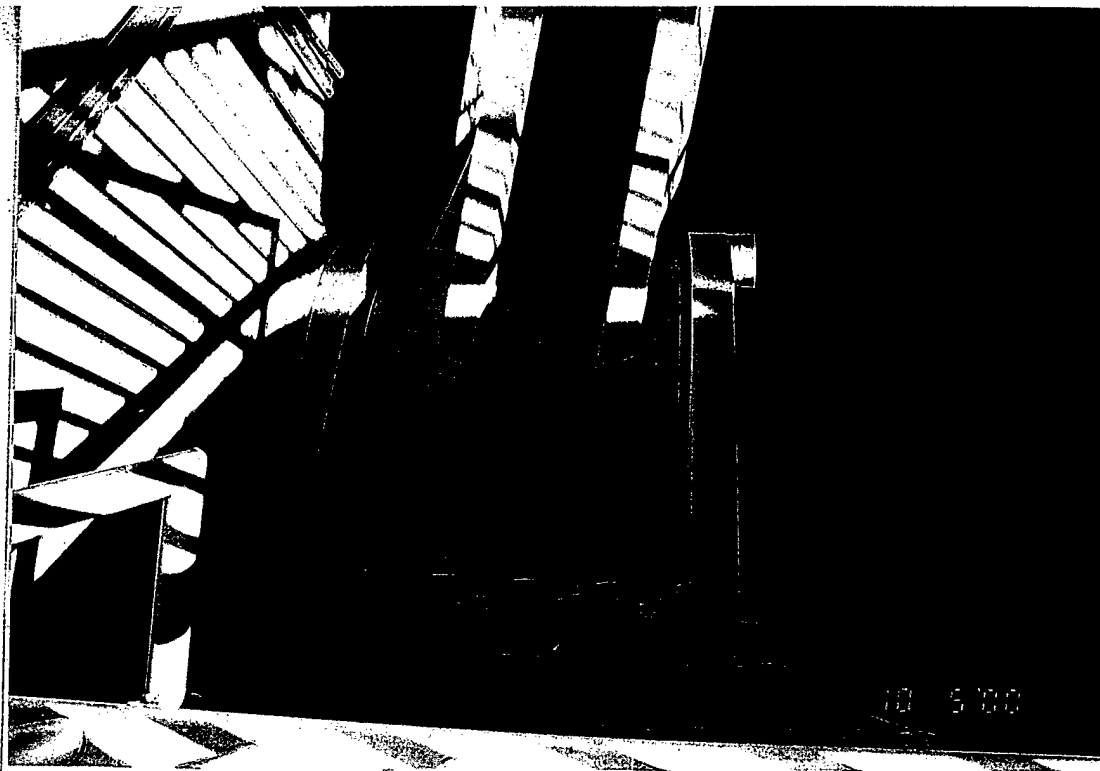
2-16

Gate 2
Gate face and side frames, typical

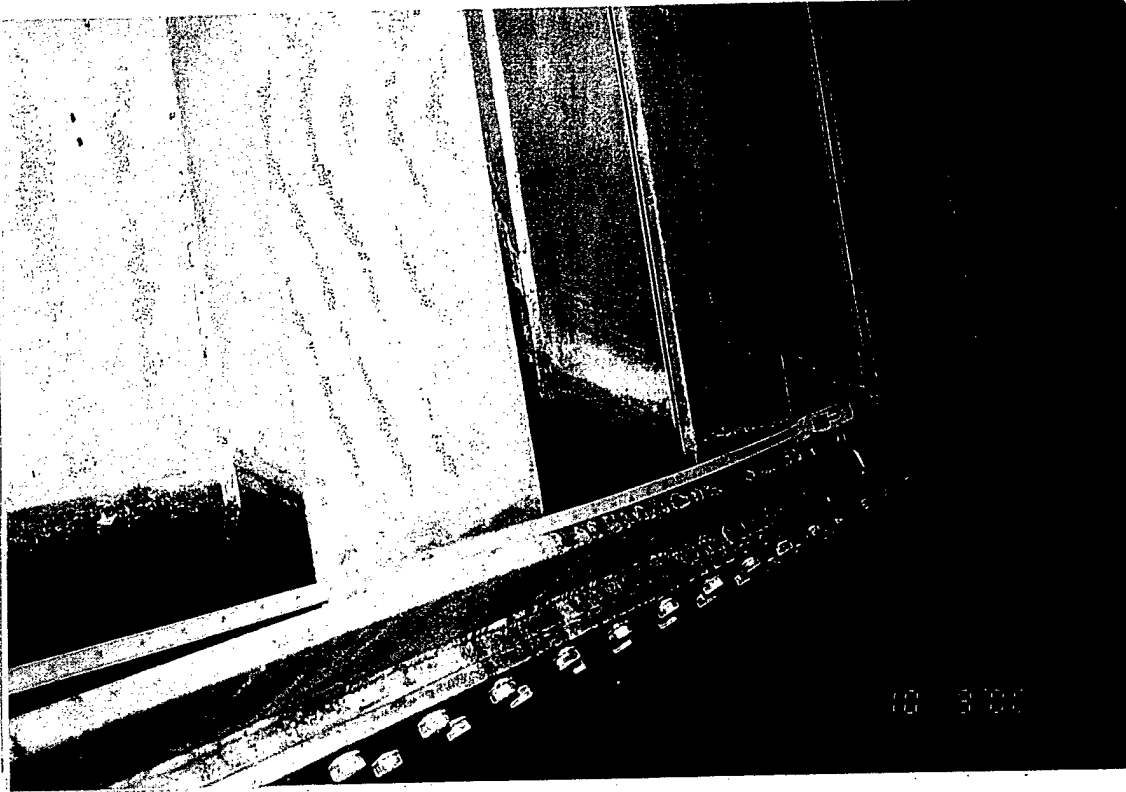
2-18

Gate 2
Bottom seal closure plate looking
upstream. Standing water between
closure plate, purlin webs and
skinplate. Typical.

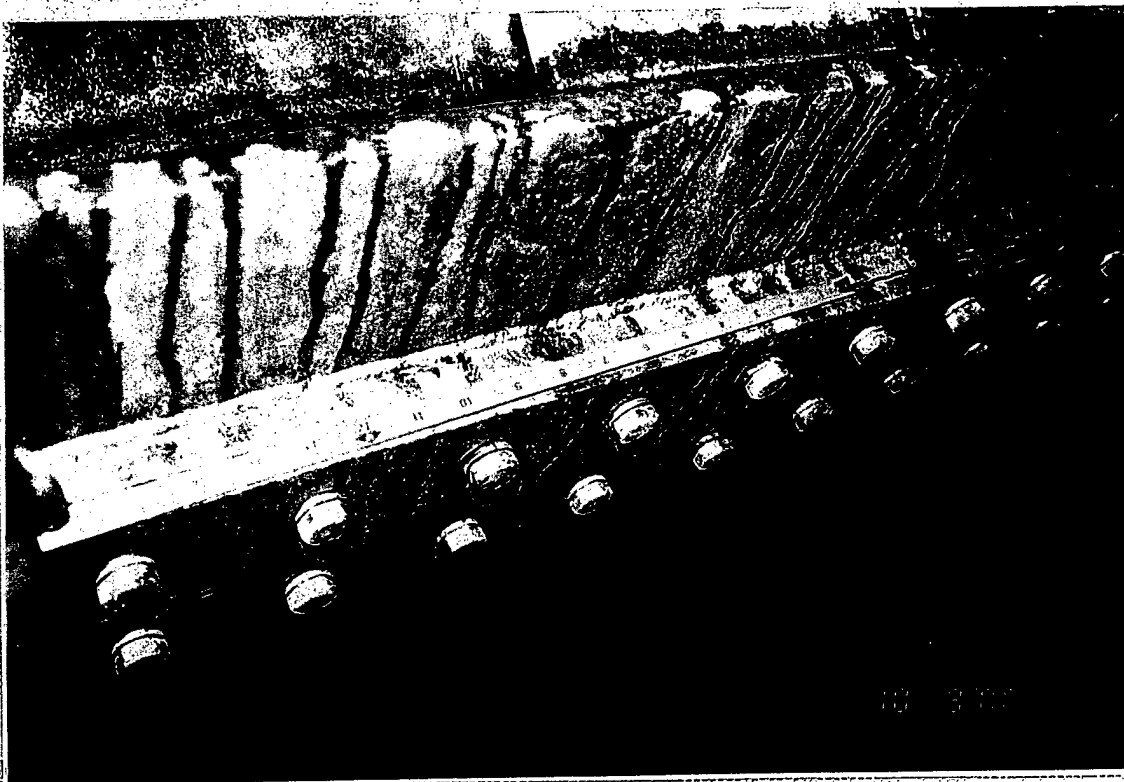
Gate 2

Bottom seal closure plate looking
upstream. Standing water between
closure plate, purlin webs and
skinplate. Typical.

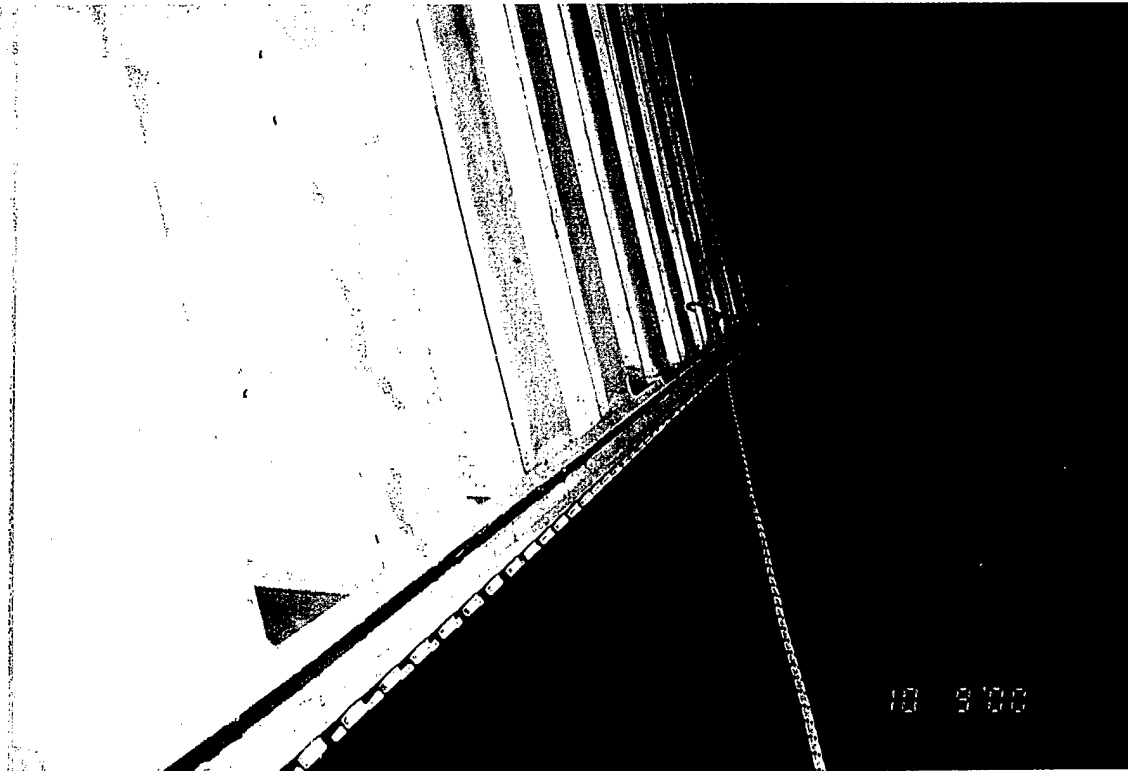
2-28

Gate 2
Upstream side of bottom seal and
bottom of skin plate. Light to
moderate corrosion on skin plate.

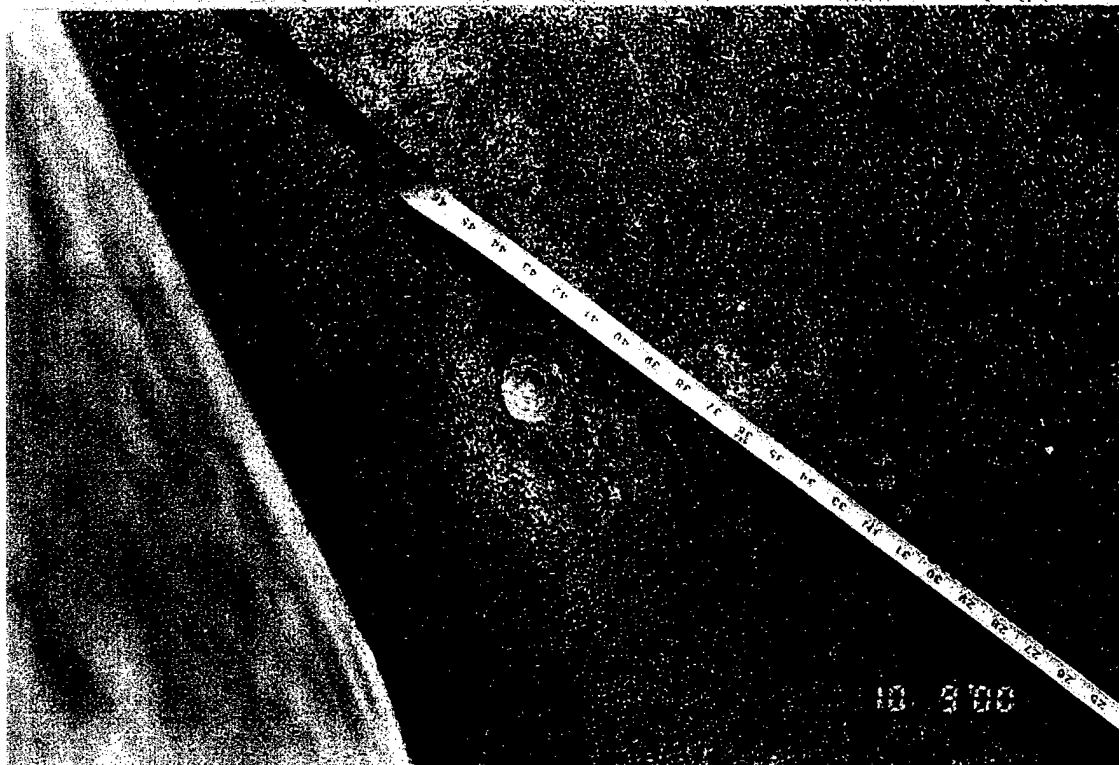
2-31

Gate 2
Waterblasting of skin plate pitting,
typical.

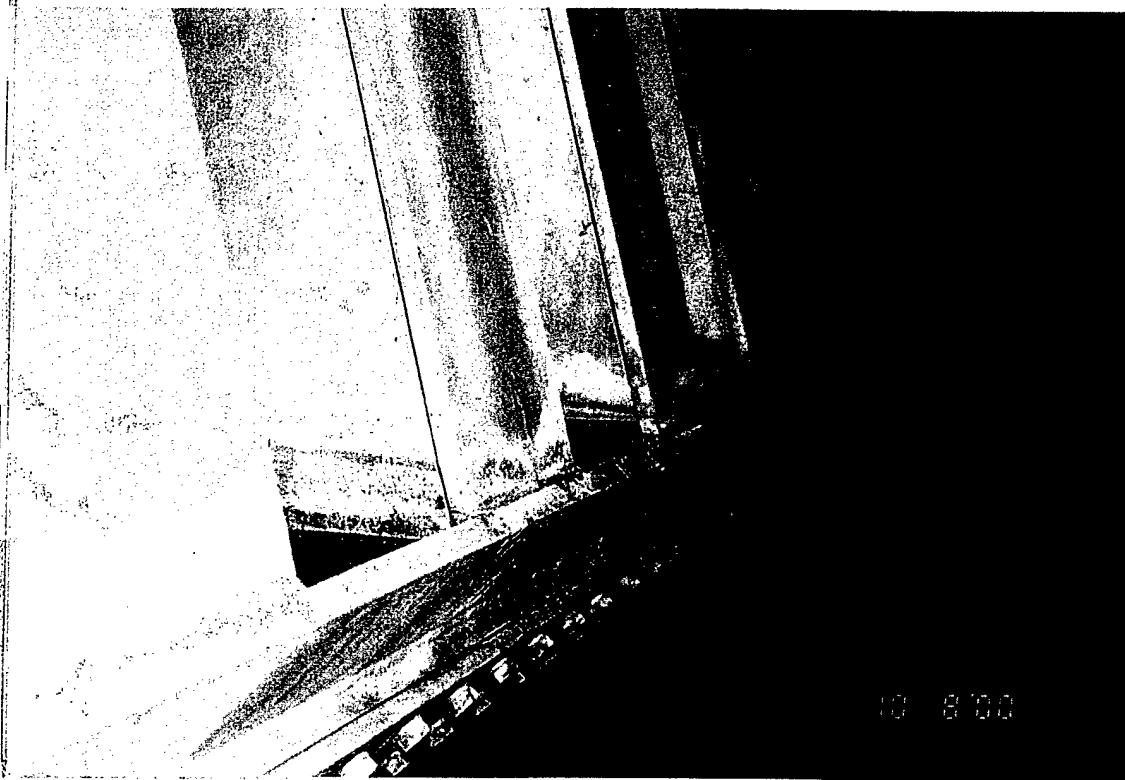
3-26

Gate 3
Downstream side of bottom seal and
keeper plate looking upstream.

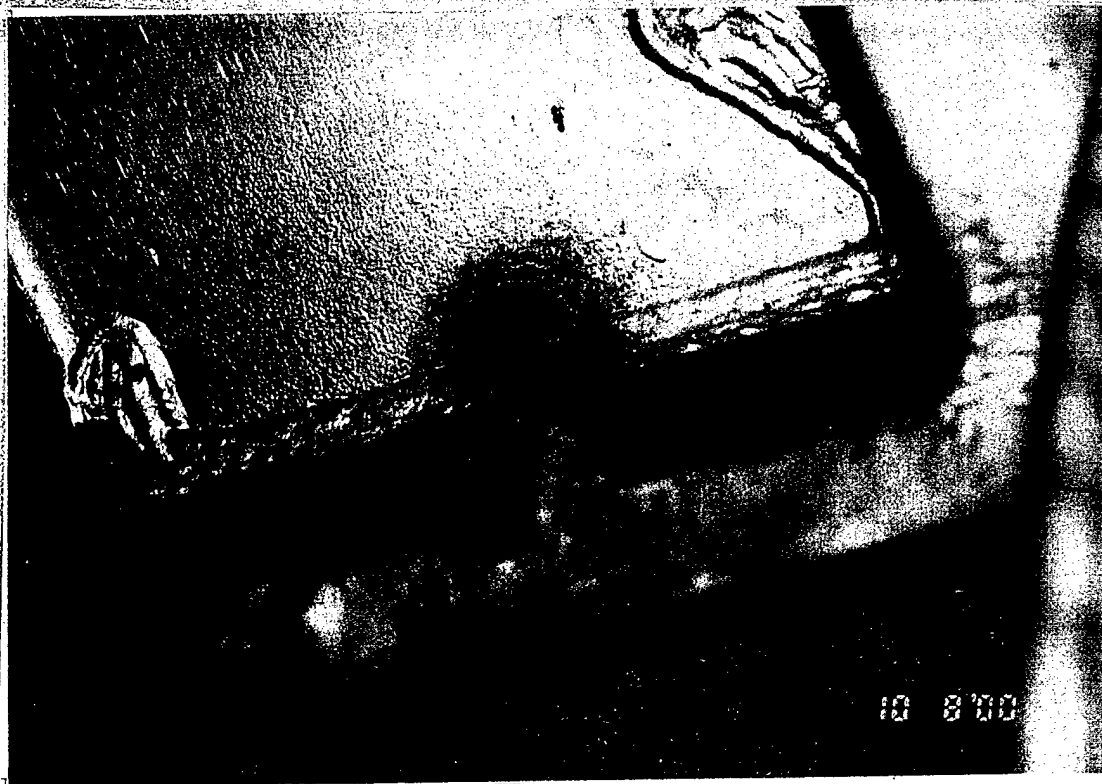
Right end of bottom horiz. girder.
Evidence of standing water, no
drainage between multiple stiffeners.
Horiz. girder to skin plate stiffeners,
debris and no drainage

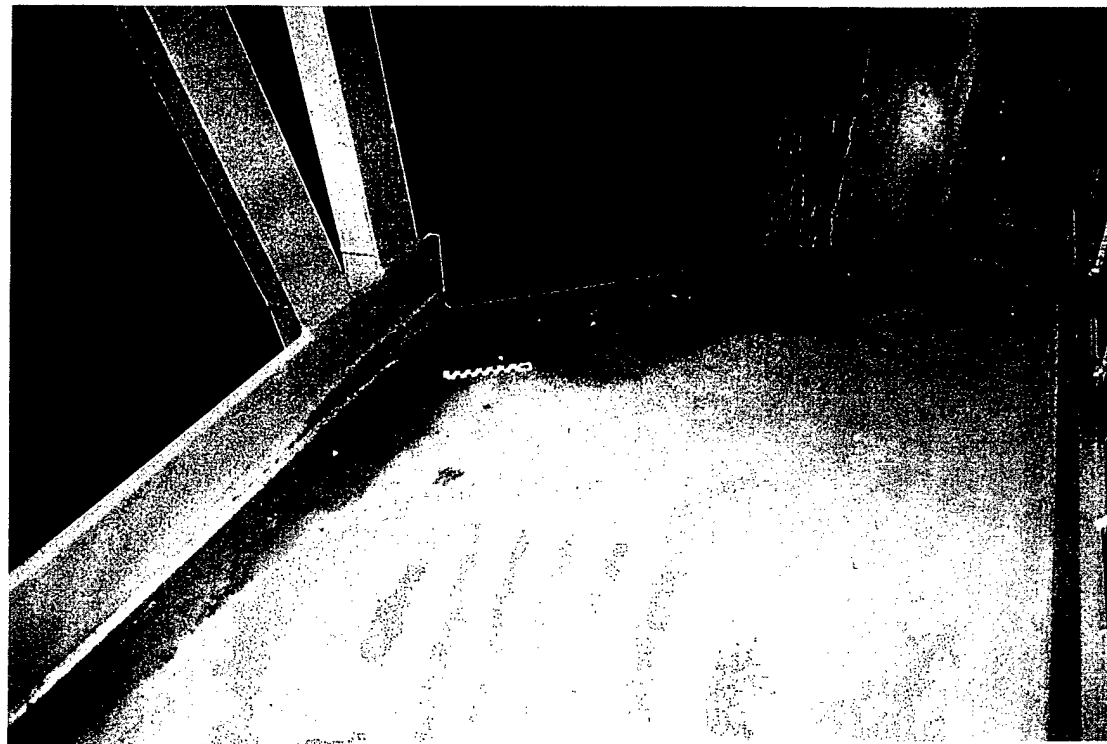
Right end of middle horizontal girder.
Light corrosion due to side seal leak.

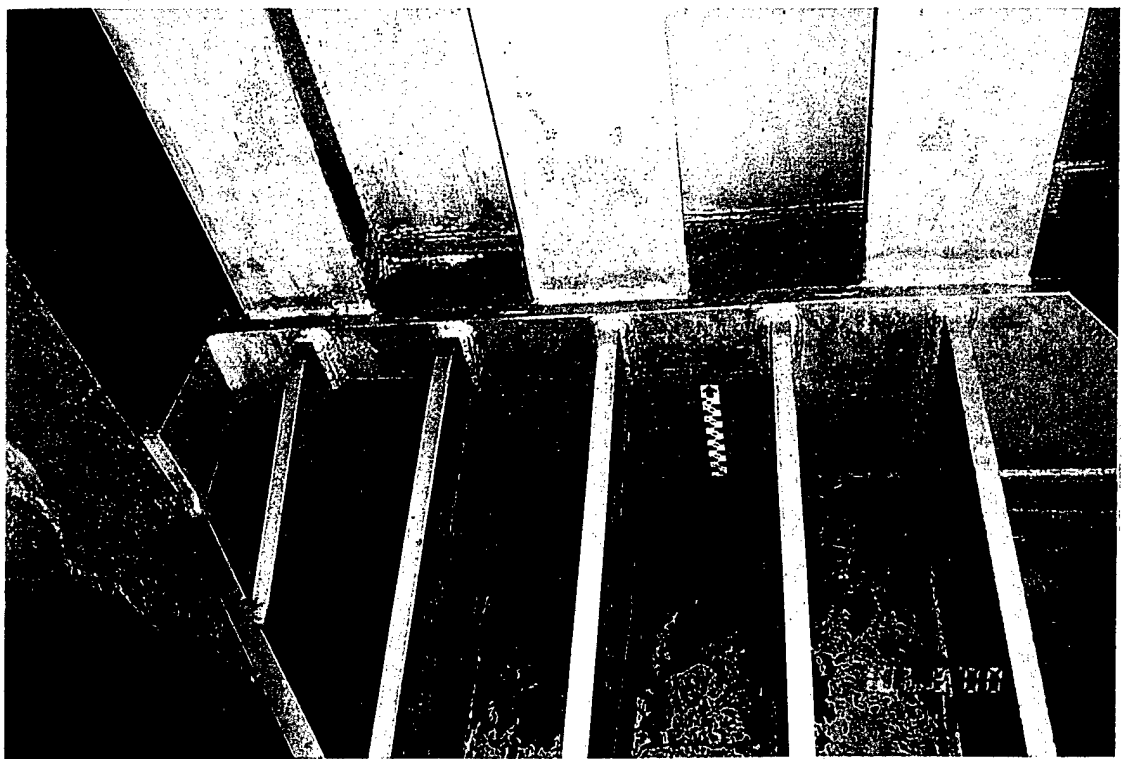
Right end of bottom horizontal girder.
Standing water, no drainage between
multiple stiffeners. Horizontal girder
to skin plate stiffeners, standing
water, debris and no drainage

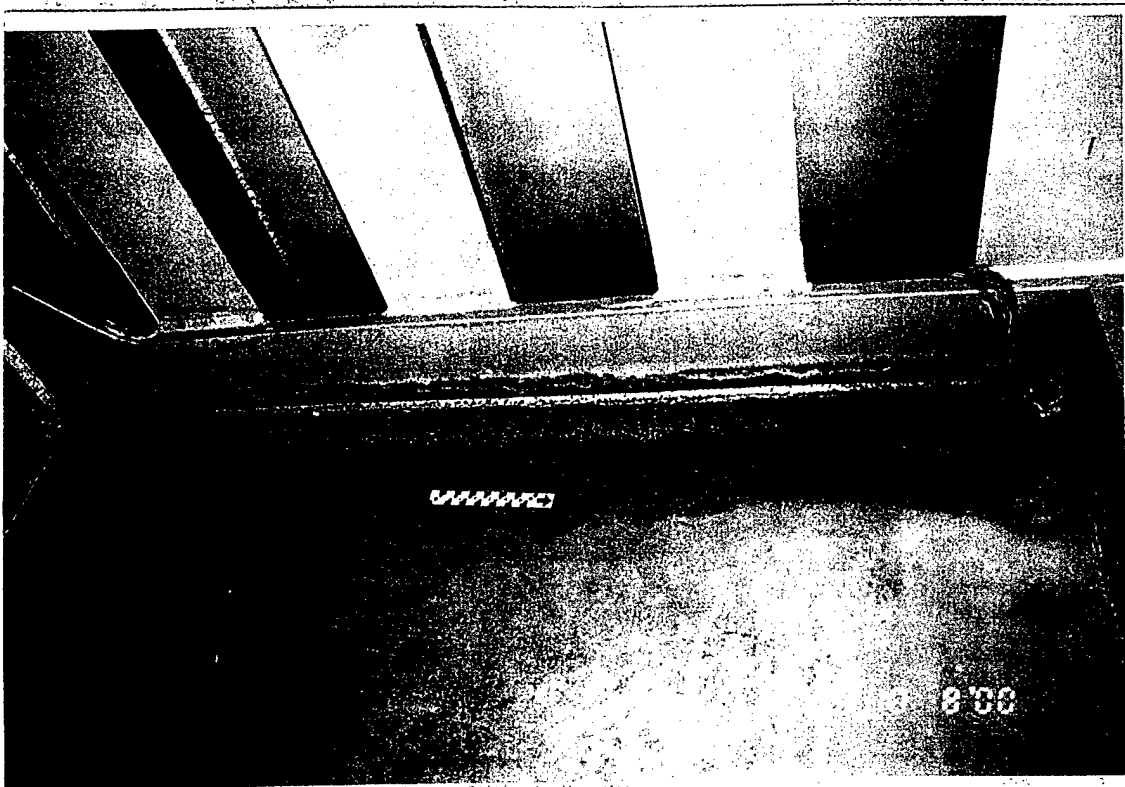
Left end of bottom horizontal girder.
Standing water, inadequate drainage
between stiffeners.

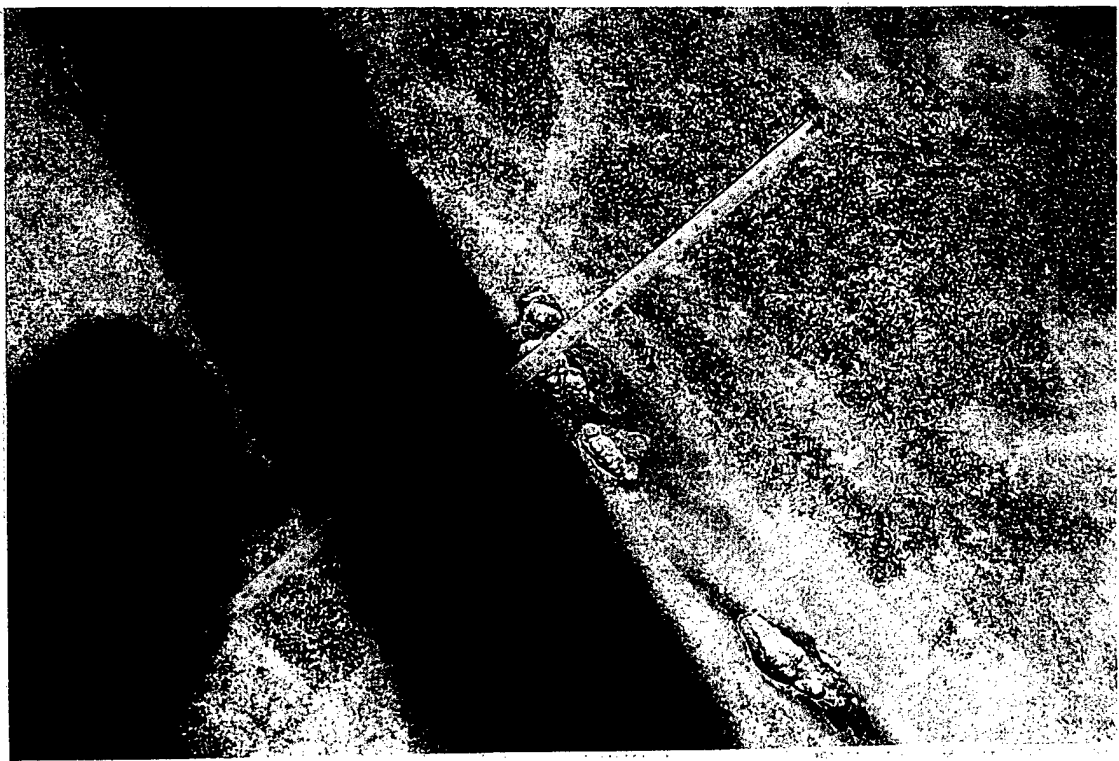
6-28

Lower Gate 6
Granite Waterblasting of skin plate, typical.
Dam

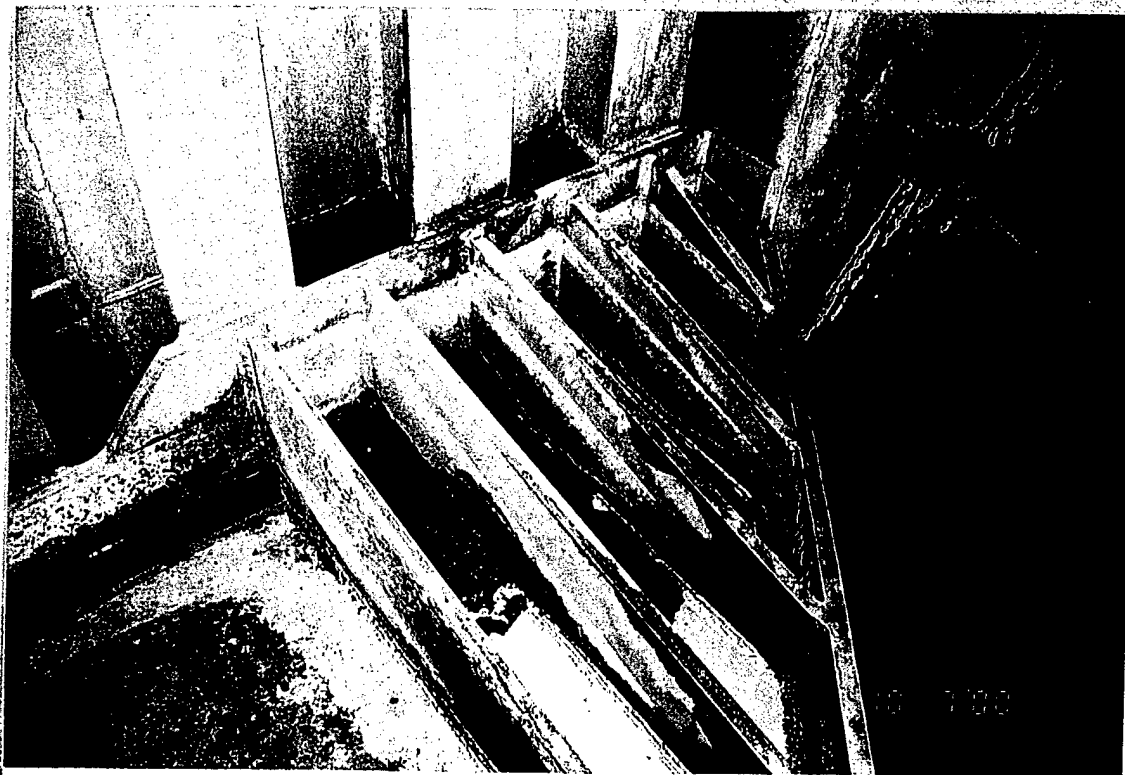
Horizontal girder stiffeners at left
frame middle radial strut. Note:
upstream end of stiffeners not welded
to girder flange. Correct per plans.

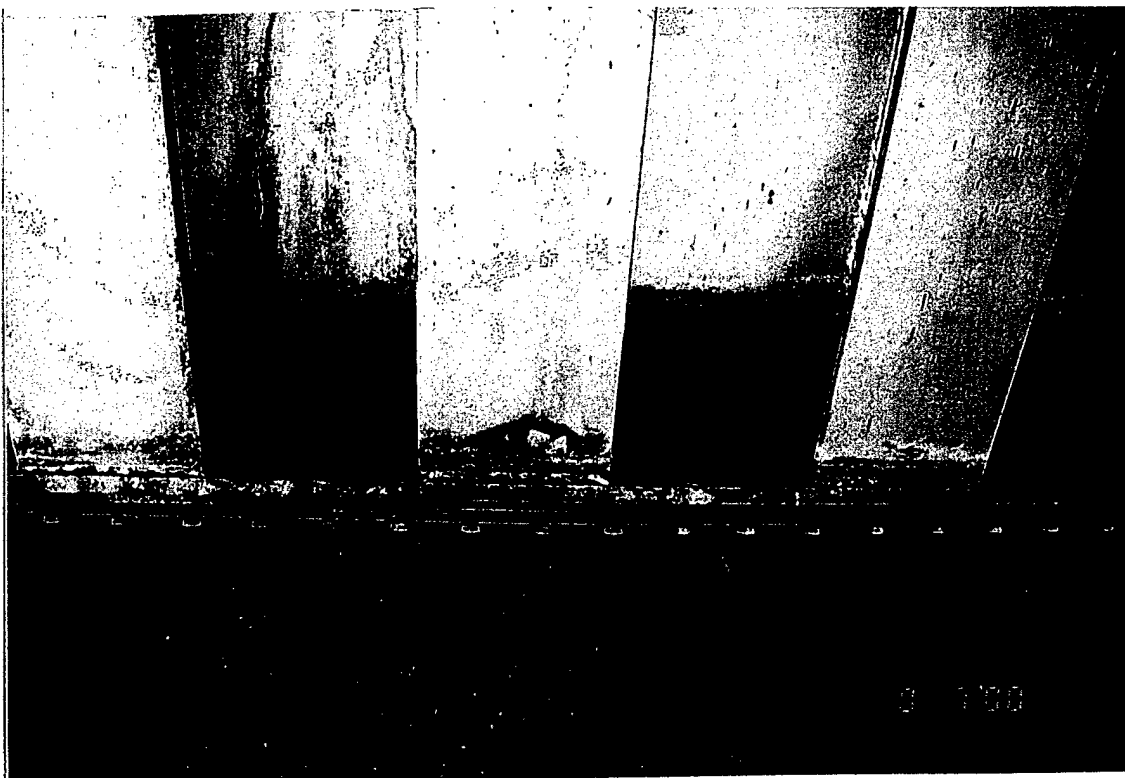
Left end of bottom horizontal girder.
Standing water, no drainage between
multiple stiffeners. Horizontal girder
to skin plate stiffeners, standing
water, debris and no drainage

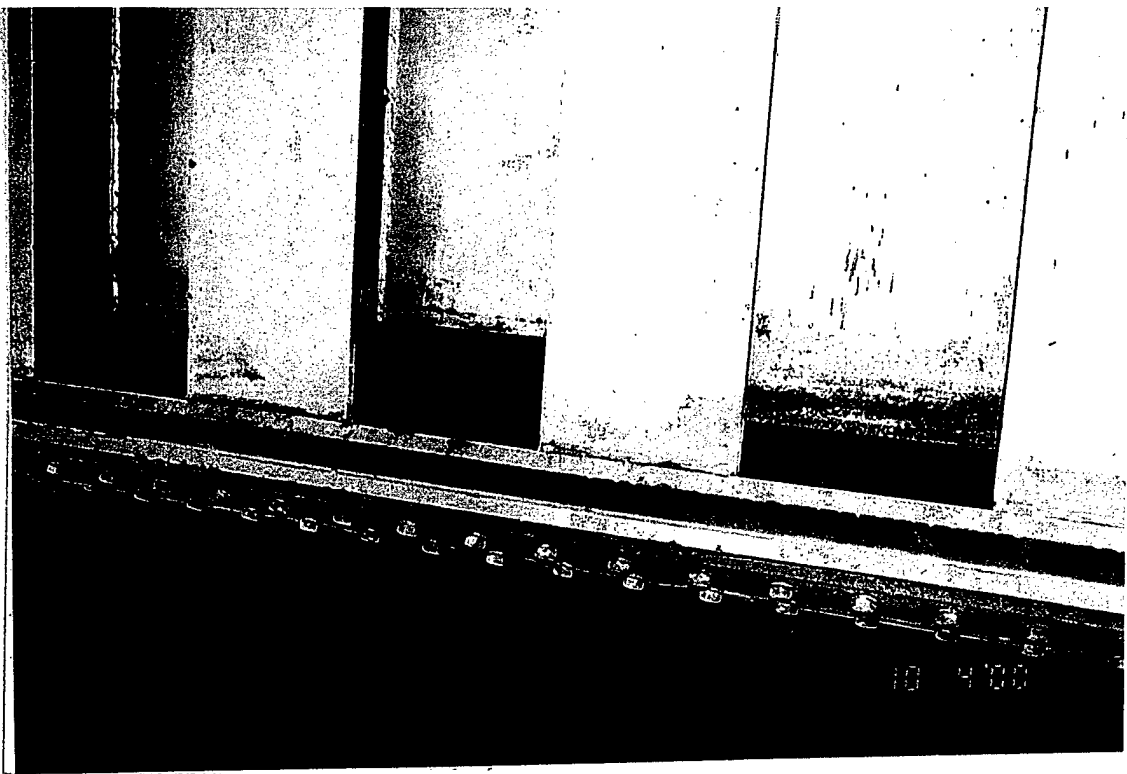
Upstream surface of skin plate,
typical. Note: Weld lines for purlins
visible through 3/8" skin plate.

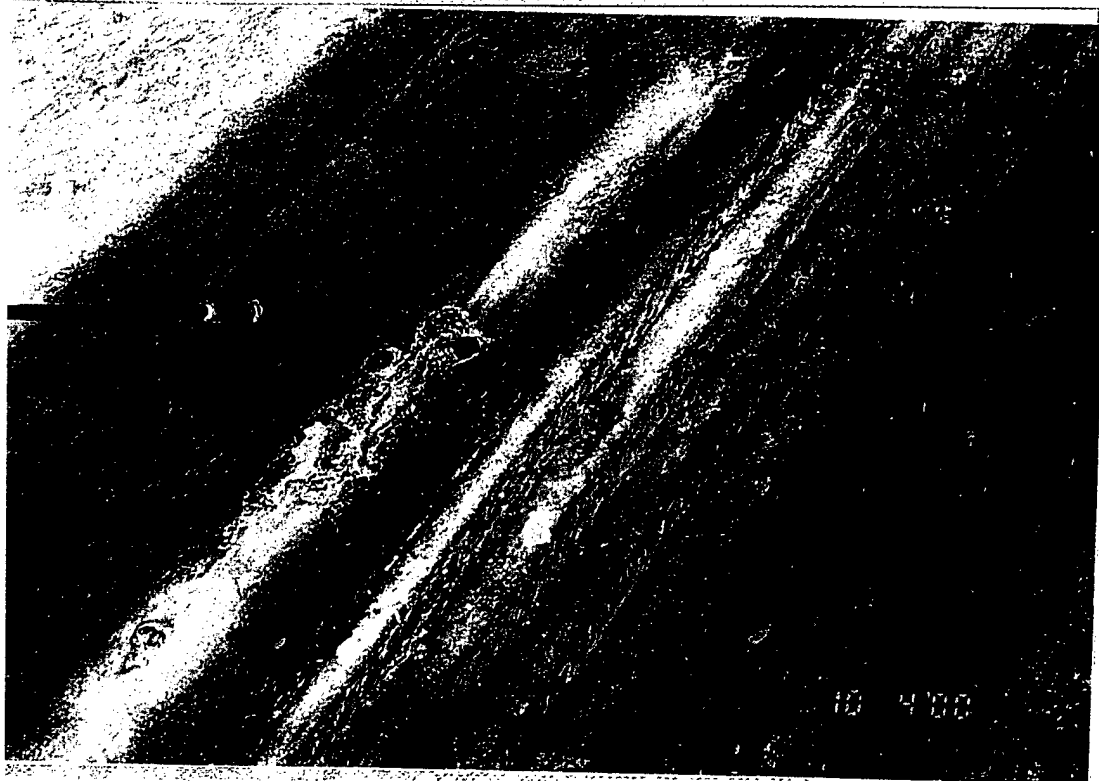
Skin plate pitting, typical. Note:
Pitting appears to be oriented in line
associated with scratch.

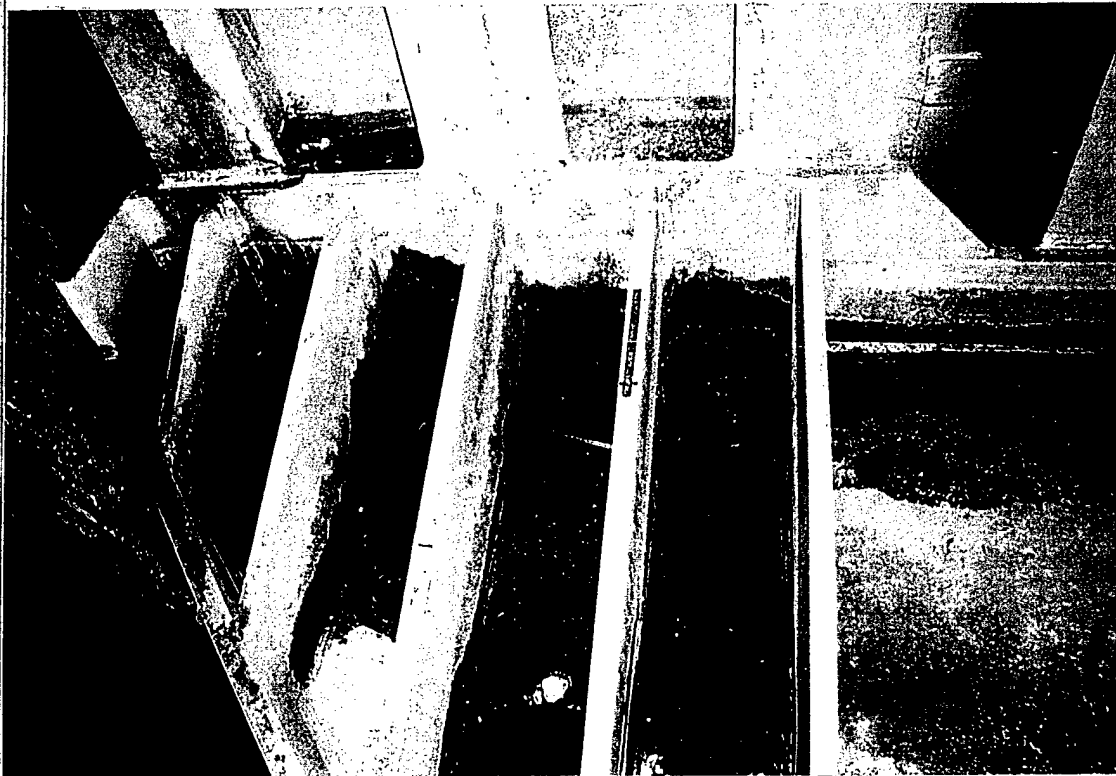
Right upstream end of bottom
horizontal girder. Standing water at
upstream flange and web.
